**RE: Drinking Water Sampling – Valley Junior and Senior High School**  
#1 Viking Drive  
Caledonia, MO 63631  
**Project Number: 923206**

Drinking Water Assessment  
Valley High School  
Valley School District

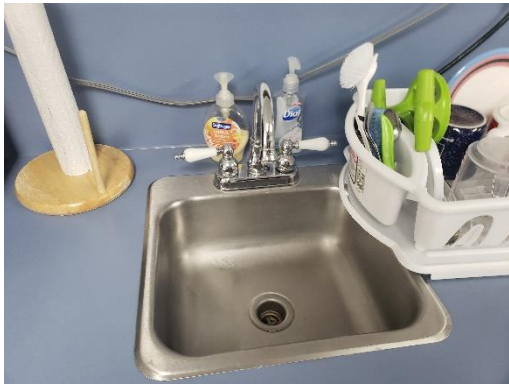
ID:	206-VHS-01	Location:	Admin Office	
Photo:

Manufacturer:	Unknown	
		Description:		
		South Wall Main Office Kitchenette Sink		
		Result:	1.8	ppb
		Date Sampled:	8/1/2023	By: NJ
Recommended Action:

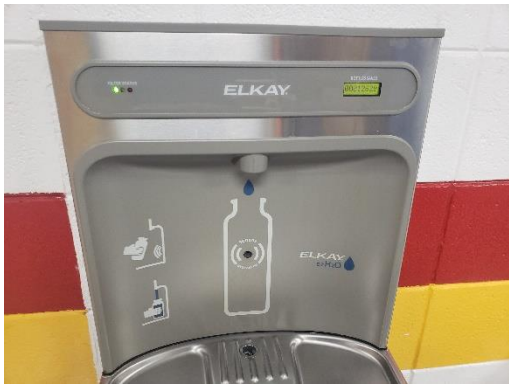
ID:	206-VHS-02	Location:	Jr. High East Wing	
Photo:

Manufacturer:	Elkay	
		Description:		
		Drinking Fountain Bottle Filler		
		Result:	<1.0	ppb
		Date Sampled:	8/1/2023	By: NJ
Recommended Action:

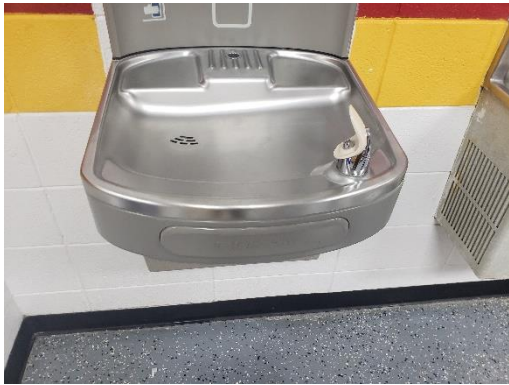
ID:	206-VHS-03	Location:	Jr. High East Wing	
Photo:

Manufacturer:	Elkay	
		Description:		
		Drinking Fountain Bubbler, Left		
		Result:	<1.0	ppb
		Date Sampled:	8/1/2023	By: NJ
Recommended Action:

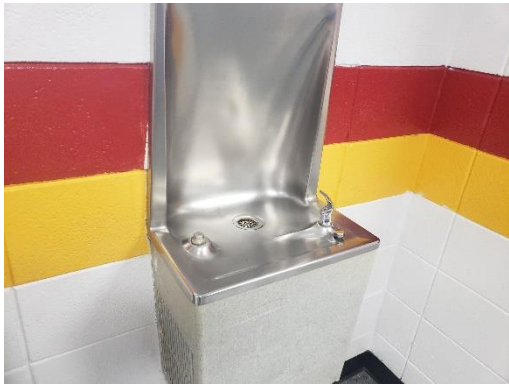
ID:	206-VHS-04	Location:	Jr. High East Wing	
Photo:

Manufacturer:	Halsey-Taylor (?)	
		Description:		
		Drinking Fountain Bubbler, Right (Non-Functional)		
		Result:	<1.0	ppb
		Date Sampled:	8/1/2023	By: NJ
Recommended Action:

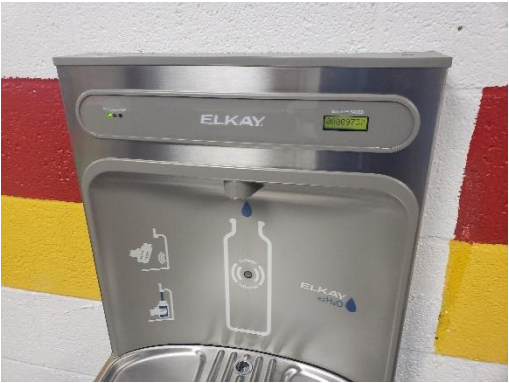
ID:	206-VHS-05	Location:	High School Center	
Photo:

Manufacturer:	Elkay	
		Description:		
		Drinking Fountain Bottle Filler, near Men's Restroom		
		Result:	<1.0	ppb
		Date Sampled:	8/1/2023	By: NJ
Recommended Action:

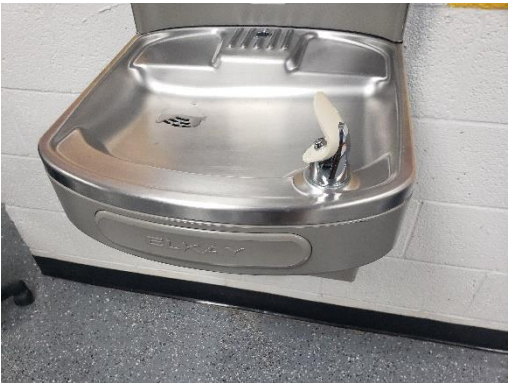
ID:	206-VHS-06	Location:	High School Center	
Photo:

Manufacturer:	Elkay	
		Description:		
		Drinking Fountain Bubbler		
		Result:	<1.0	ppb
		Date Sampled:	8/1/2023	By: NJ
Recommended Action:

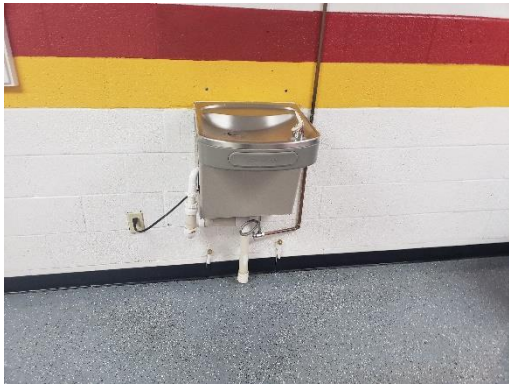
ID:	206-VHS-07	Location:	High School East Wing	
Photo:

206-VHS-07	High School East Wing	Drinking Fountain Bubbler	7.9
206-VHS-12	High School West Wing	Drinking Fountain Bubbler (Left Unit)	5.9
206-VHS-18	Kitchen	Kitchen Dish Sprayer	12.4
206-VHS-20	Kitchen	Faucet with Dish Sprayer	9.8

Manufacturer:	Elkay	
		Description:		
		Standalone Drinking Fountain Bubbler		
Result:			ppb	
Date Sampled:		8/1/2023	By:	NJ
Recommended Action:

In accordance with the requirements set forth in Missouri Bill 681/662, fixtures exhibiting lead concentrations above 5 ppb must be remediated by replacement of lead-containing pipes, solder, fittings or fixtures with lead-free components, or the school shall install filtration at each point where water enters the building until such time as the source can be remediated. If installing a filter is not feasible, the school shall provide purified water at each outlet inventoried.

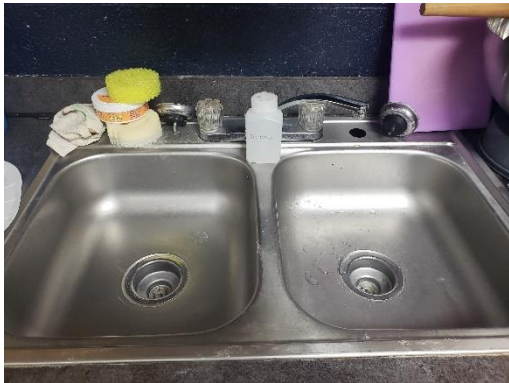
ID:	206-VHS-09	Location:	Home Ec. Classroom	
Photo:

Manufacturer:	Unknown	
		Description:		
		NE Kitchenette Sink		
Result:		1.2	ppb	
Date Sampled:		8/1/2023	By:	NJ
Recommended Action:

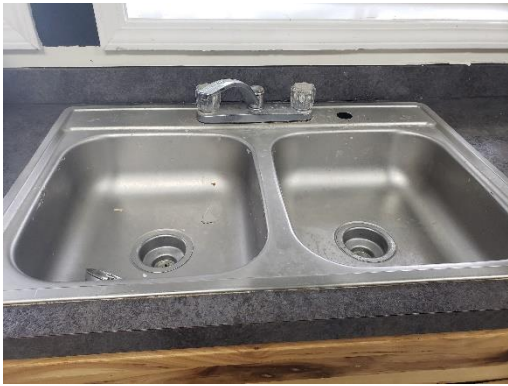
ID:	206-VHS-10	Location:	Home Ec. Classroom	
Photo:

Manufacturer:	Unknown	
		Description:		
		SE Kitchenette Sink		
		Result:	1.6	ppb
		Date Sampled:	8/1/2023	By: NJ
Recommended Action:

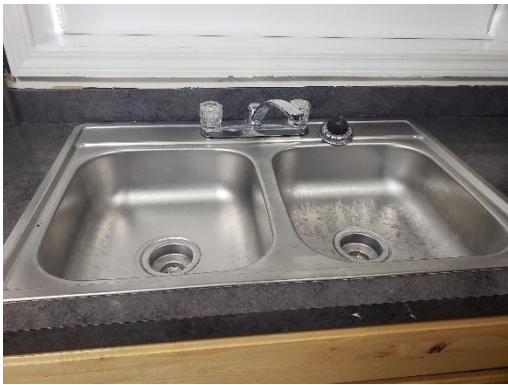
ID:	206-VHS-11	Location:	Home Ec. Classroom	
Photo:

Manufacturer:	Unknown	
		Description:		
		SW Kitchenette Sink		
		Result:	3.7	ppb
		Date Sampled:	8/1/2023	By: NJ
Recommended Action:

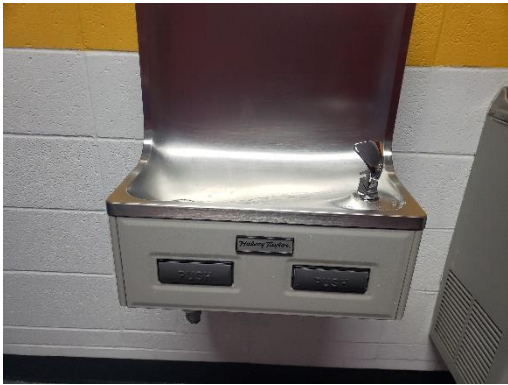
ID:	206-VHS-12	Location:	High School West Wing	
Photo:

Manufacturer:	Halsey-Taylor	
		Description:		
		Drinking Fountain Bubbler, Left		
		Result:		ppb
		Date Sampled:	8/1/2023	By: NJ
Recommended Action:

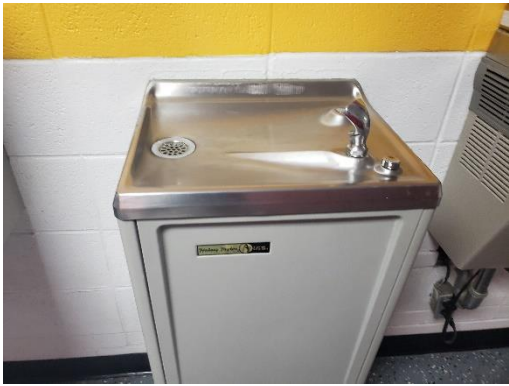
ID:	206-VHS-13	Location:	High School West Wing	
Photo:

Manufacturer:	Halsey-Taylor	
		Description:		
		Drinking Fountain Bubbler, Center (Non-Functional)		
		Result:	<1.0	ppb
		Date Sampled:	8/1/2023	By: NJ
Recommended Action:

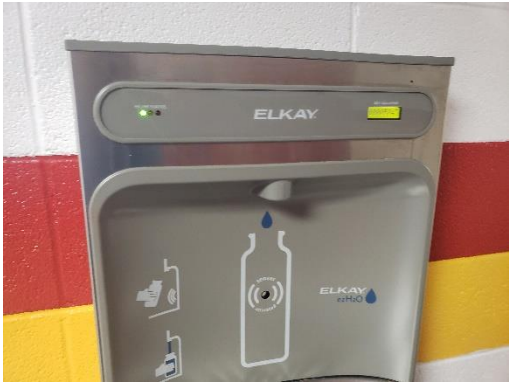
ID:	206-VHS-14	Location:	High School West Wing	
Photo:

Manufacturer:	Elkay	
		Description:		
		Drinking Fountain Bottle Filler		
		Result:	<1.0	ppb
		Date Sampled:	8/1/2023	By: NJ
Recommended Action:

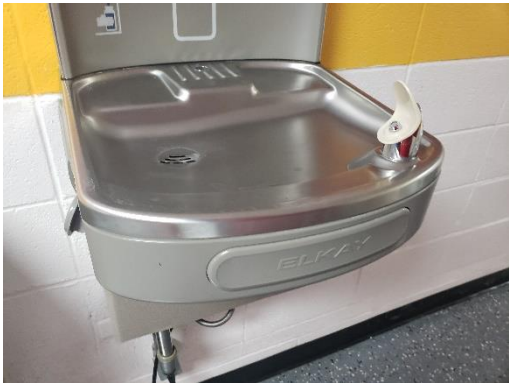
ID:	206-VHS-15	Location:	High School West Wing	
Photo:

Manufacturer:	Elkay	
		Description:		
		Drinking Fountain Bubbler, Right		
		Result:	<1.0	ppb
		Date Sampled:	8/1/2023	By: NJ
Recommended Action:

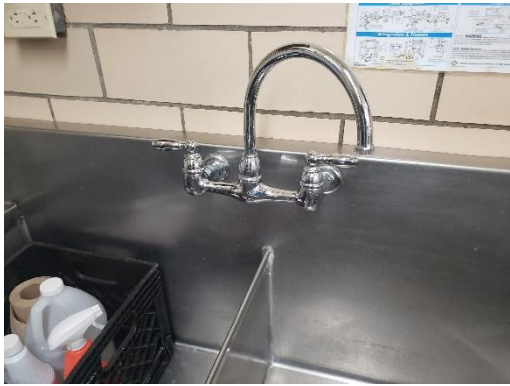
ID:	206-VHS-16	Location:	Kitchen	
Photo:

Manufacturer:	Watts	
		Description:		
		Dishwashing Sink, Left		
		Result:	<1.0	ppb
Date Sampled:		8/1/2023	By:	NJ
Recommended Action:

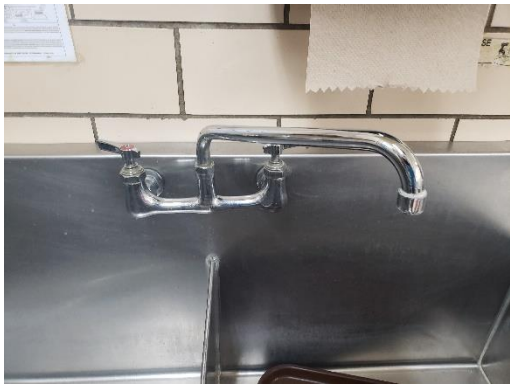
ID:	206-VHS-17	Location:	Kitchen	
Photo:

Manufacturer:	Watts	
		Description:		
		Dishwashing Sink, Right		
		Result:	<1.0	ppb
Date Sampled:		8/1/2023	By:	NJ
Recommended Action:

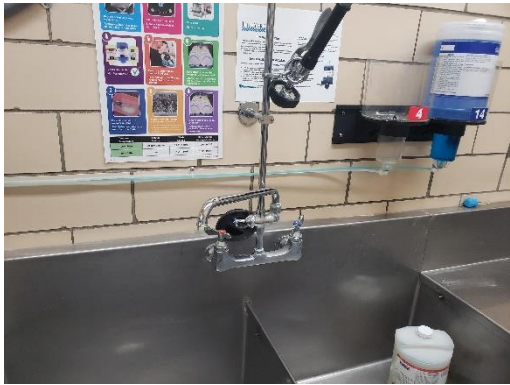
ID:	206-VHS-18	Location:	Kitchen	
Photo:

Manufacturer:	T&S Brass Co.	
		Description:		
		Kitchen Dish Sprayer		
		Result:		ppb
Date Sampled:		8/1/2023	By:	NJ
Recommended Action:

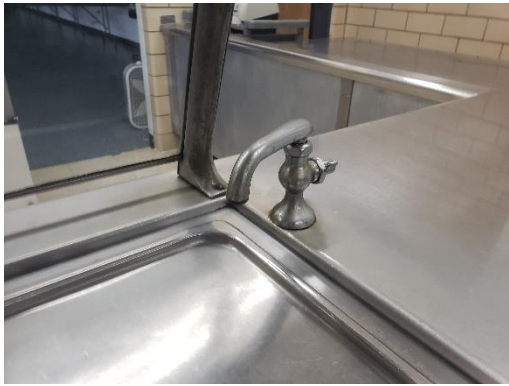
ID:	206-VHS-19	Location:	Kitchen		
Photo:

Manufacturer:	Chicago Faucet Co.		
		Description:			
		Center Island Pot Filler (Non-Functional)			
		Result:	<1.0	ppb	
Recommended Action:		Date Sampled:	8/1/2023	By:	NJ

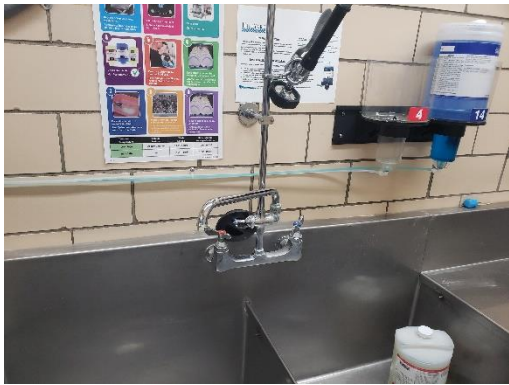
ID:	206-VHS-20	Location:	Kitchen		
Photo:

Manufacturer:	T&S Brass Co.		
		Description:			
		Sink Faucet with Kitchen Dish Sprayer			
		Result:		ppb	
Recommended Action:		Date Sampled:	8/1/2023	By:	NJ

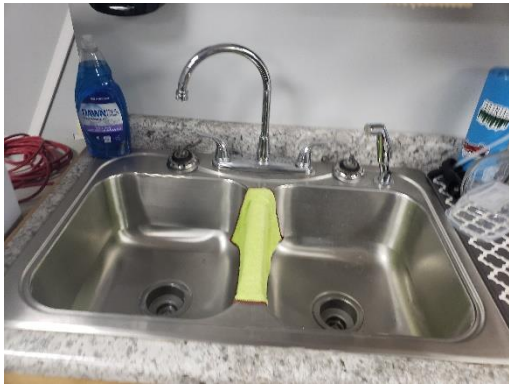
ID:	206-VHS-21	Location:	Faculty Lounge		
Photo:

Manufacturer:	Unknown		
		Description:			
		Kitchenette Sink			
		Result:	<1.0	ppb	
Recommended Action:		Date Sampled:	8/1/2023	By:	NJ

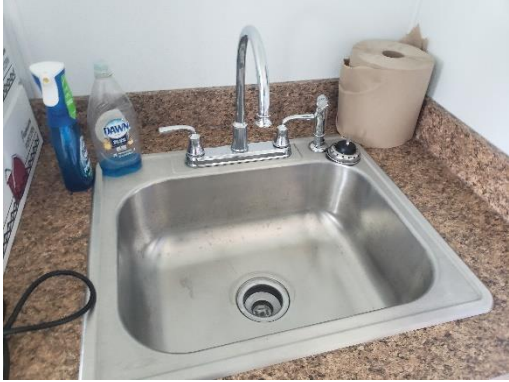
ID:	206-VHS-22	Location:	Baseball F. Concessions	
Photo:

Manufacturer:	Delta	
		Description:		
		Concession Sink		
		Result:	4.1	ppb
Recommended Action:		Date Sampled:	8/1/2023	By: NJ
